# Greater Albany Public Schools

## Facilities Assessment Study

January 14, 2015

RE: Facilities Assessment 2014

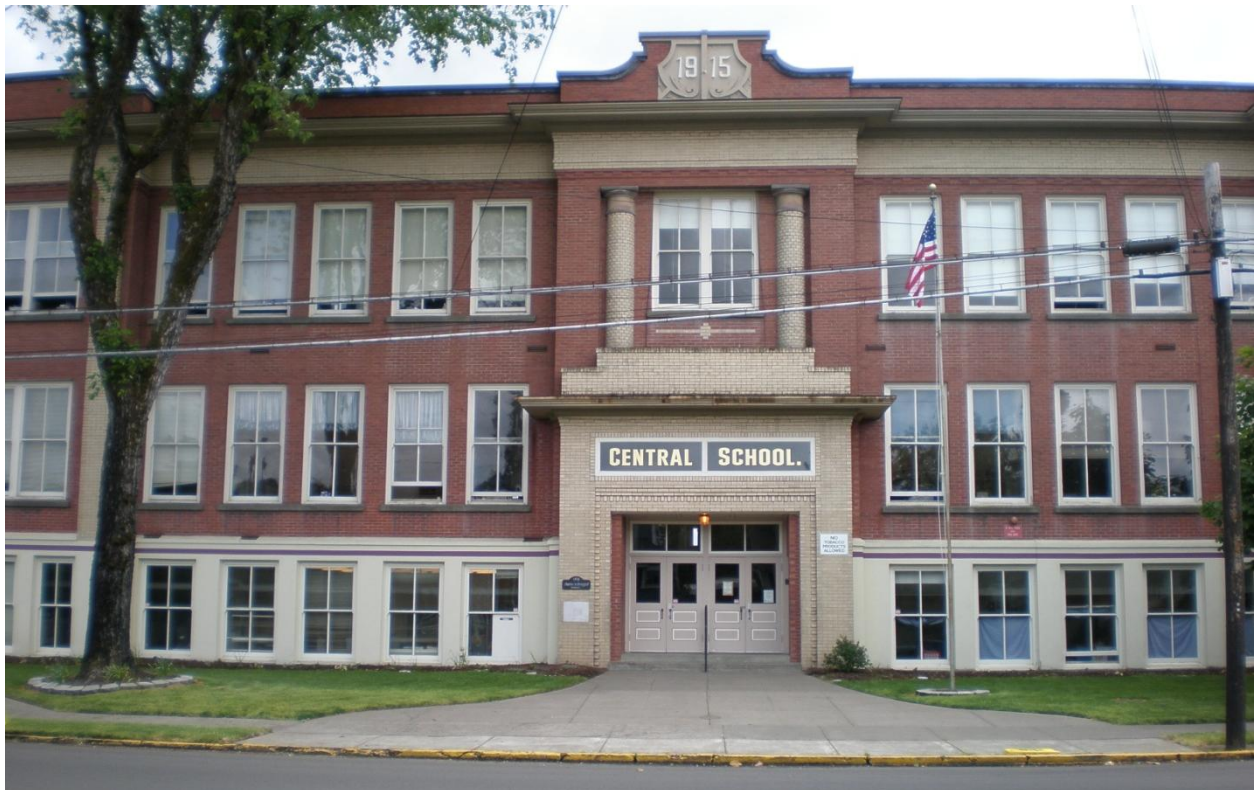
5. There is no elevator currently in the building and therefore it is not disabled accessible. In addition, the ramps that occur between floors in the building are steeper than permitted by code, and could be considered a safety hazard. Modifications to these elements are included in our recommendations.

Original front entry to Central Elementary School

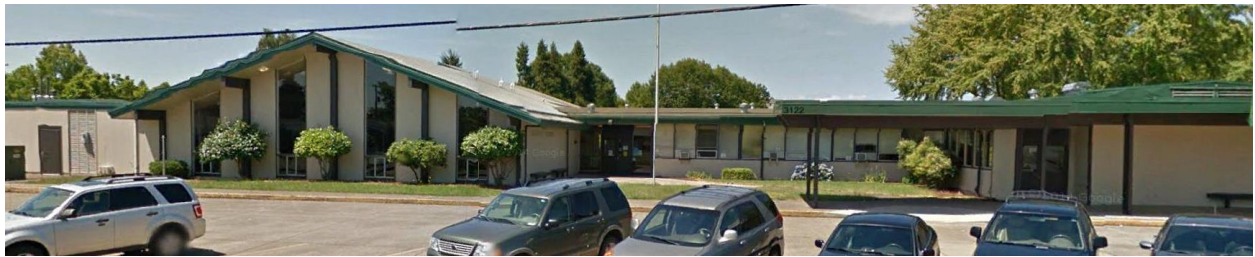
1. Lafayette has one of the best “fish bowl” reception areas in the district which provides fairly good visual surveillance of the entry. A vestibule is recommended to provide control of the entry itself.

View of main entry and cafeteria at Lafayette Elementary School

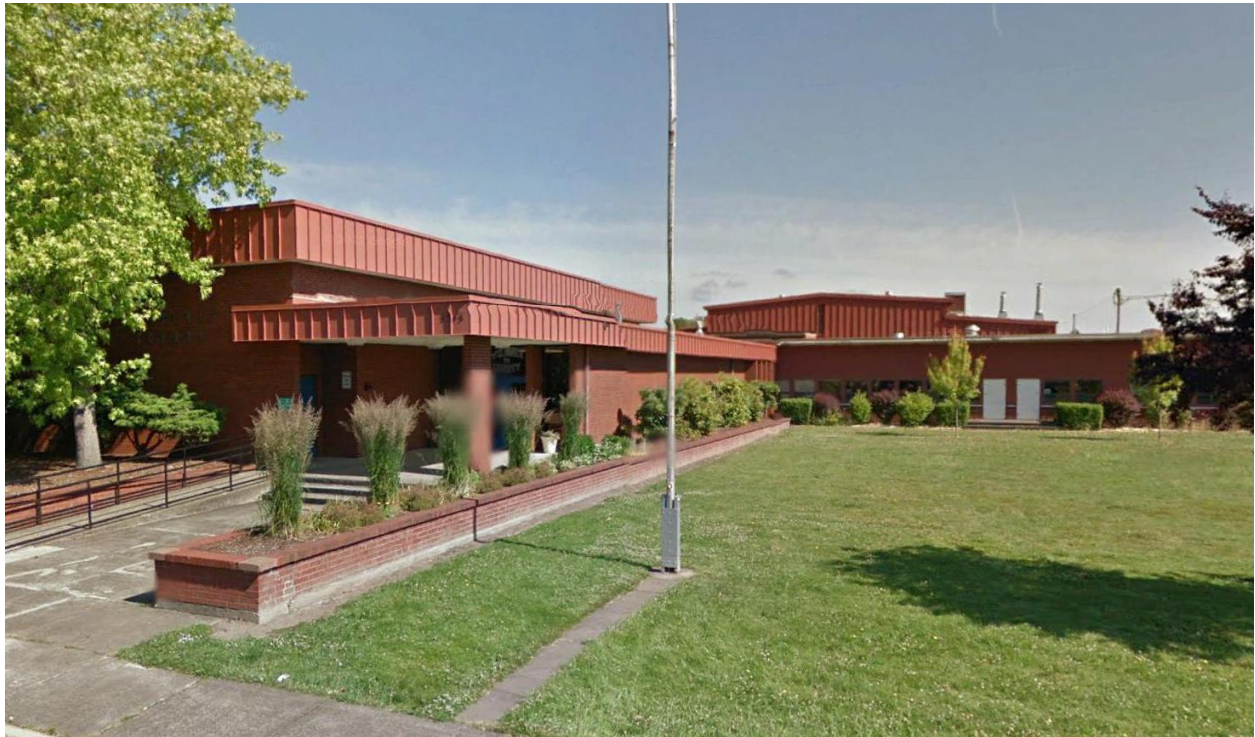
1. Extensive work has been proposed at Liberty to resolve a lack of support and office space, and to provide a controlled entry. The current administrative offices are set over 60' back from the main entry doors, which significantly compromise control of access into the facility. Recommendations include providing a new entry which can control access into the building from both the East and West sides of the building.

Primary school entrance at Liberty Elementary

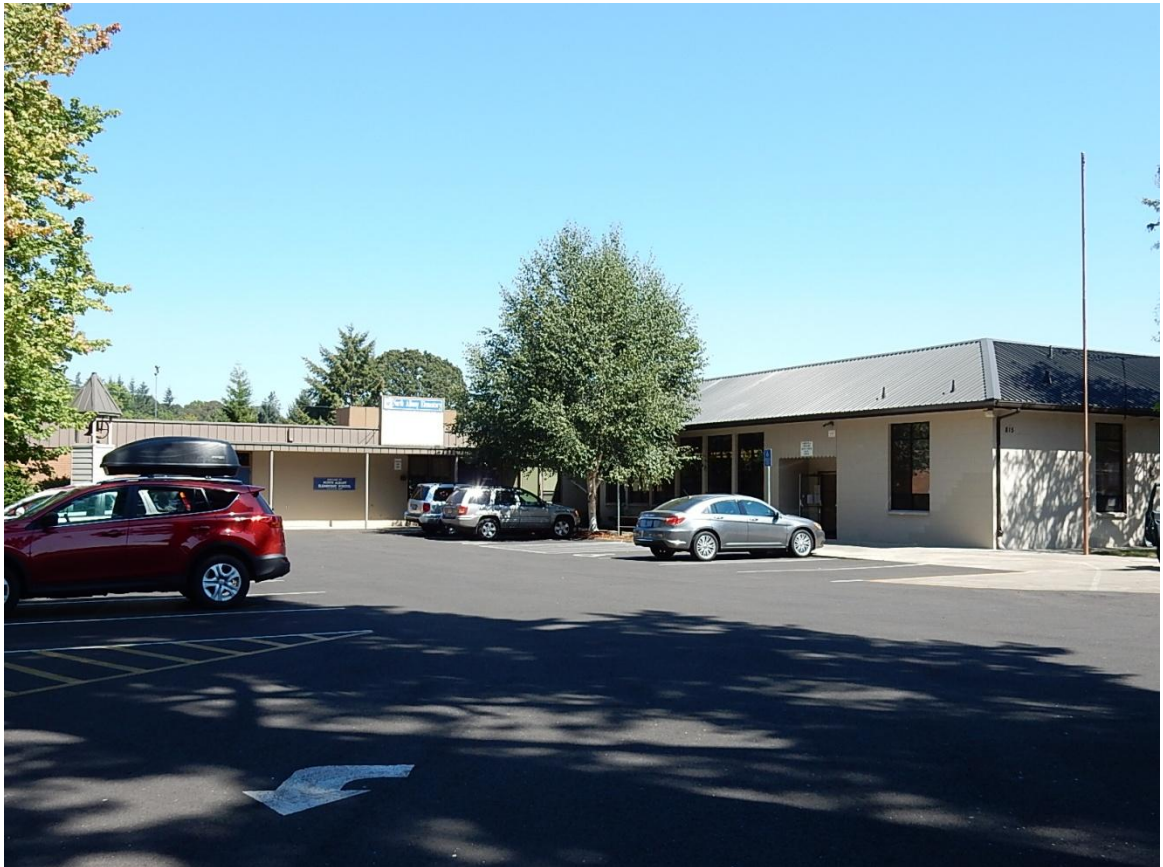
Main office entry to North Albany Elementary School

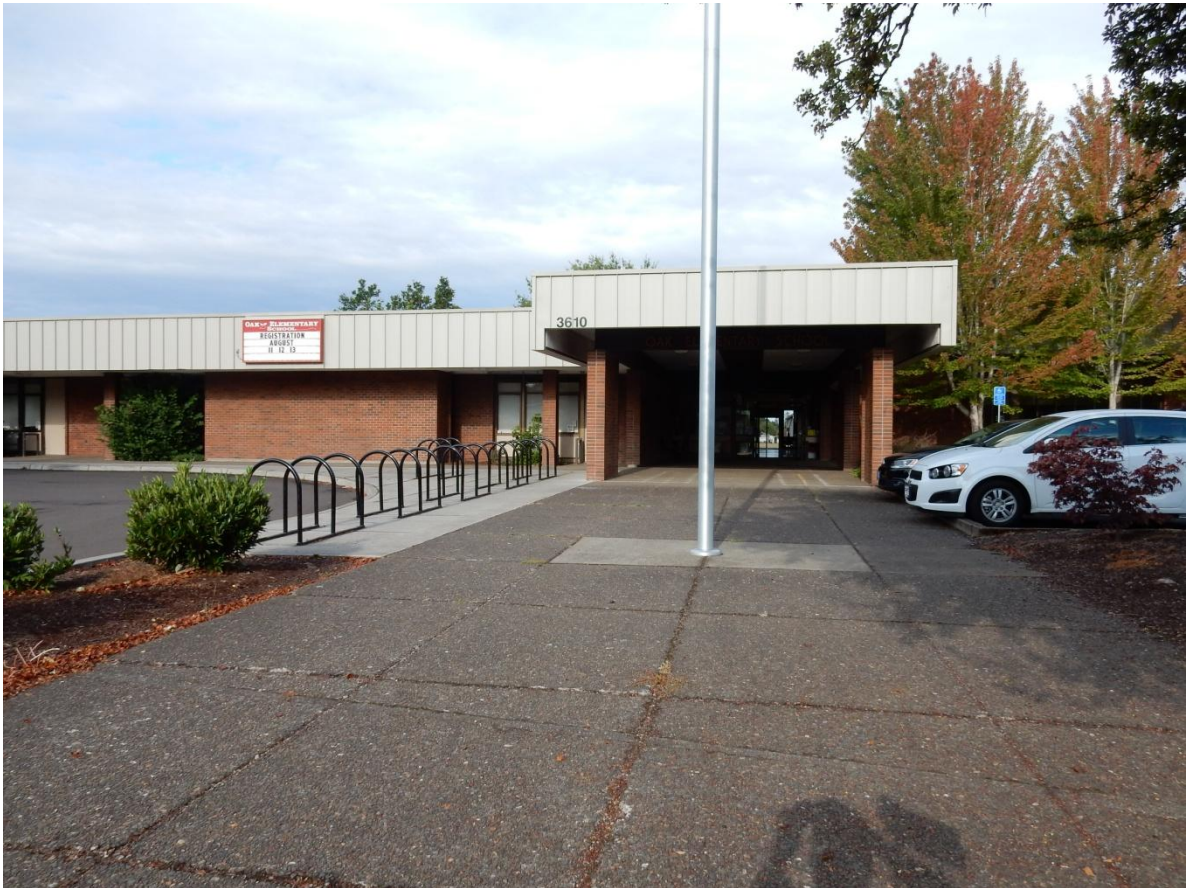
1. The existing parking lot for Oak is configured such that there is no parent loop. Parents entering the parking lot must turn around and leave by the same entry point. If a loop was created for parents, the length would only accommodate 5 or 6 cars in line, which is too few. A bus loop has been proposed since there is none, and depending on the number of buses serving the site it might be possible to shift it enough to fit a couple more cars, but not more than that. This may not be a significant enough of an improvement to justify the costs for this change. This change has not been included in the report.

Main entry to Oak Elementary School

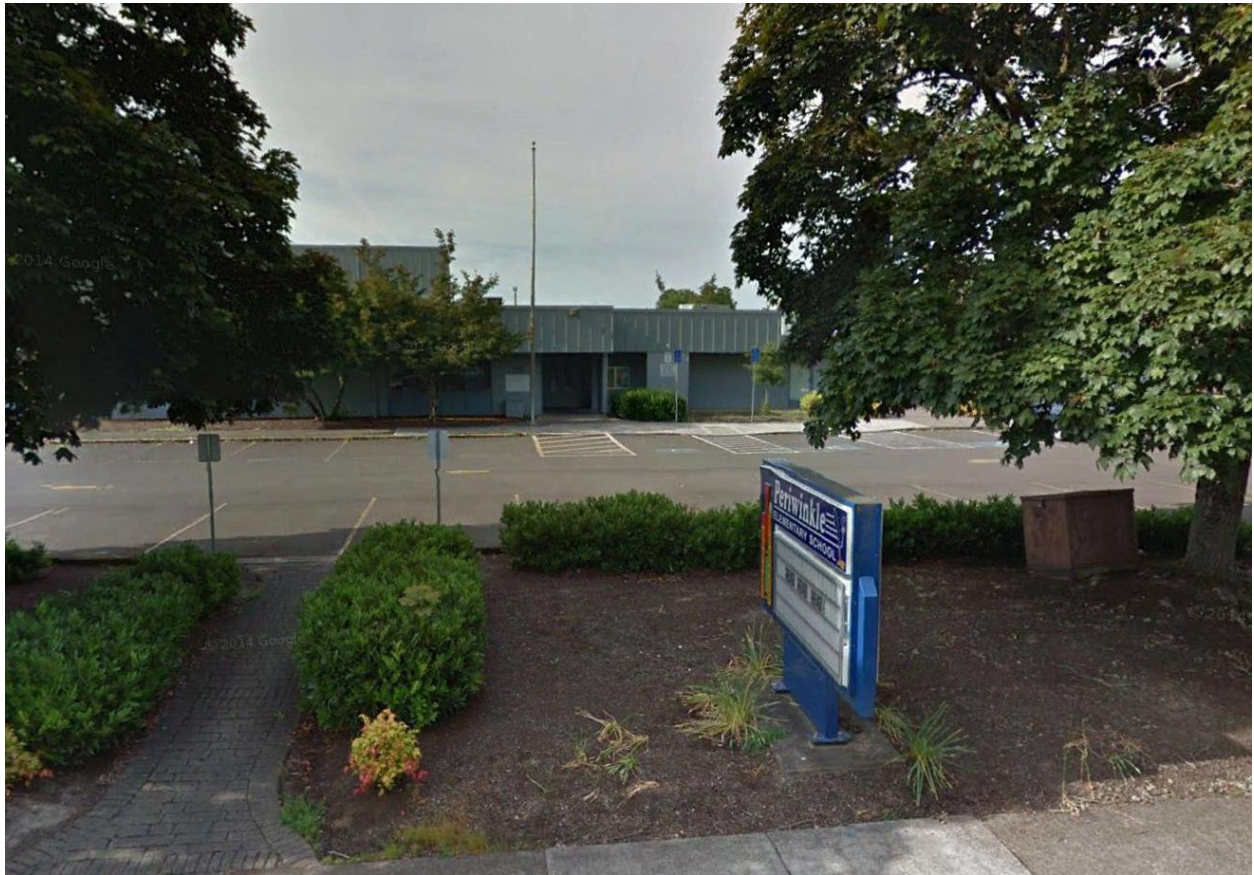
past the front office. The space is too narrow to accommodate expected traffic at the beginning and end of each school day. In order to provide for an entry lobby space could either be taken from an adjacent classroom or from the main office.

Main entry to Periwinkle Elementary School

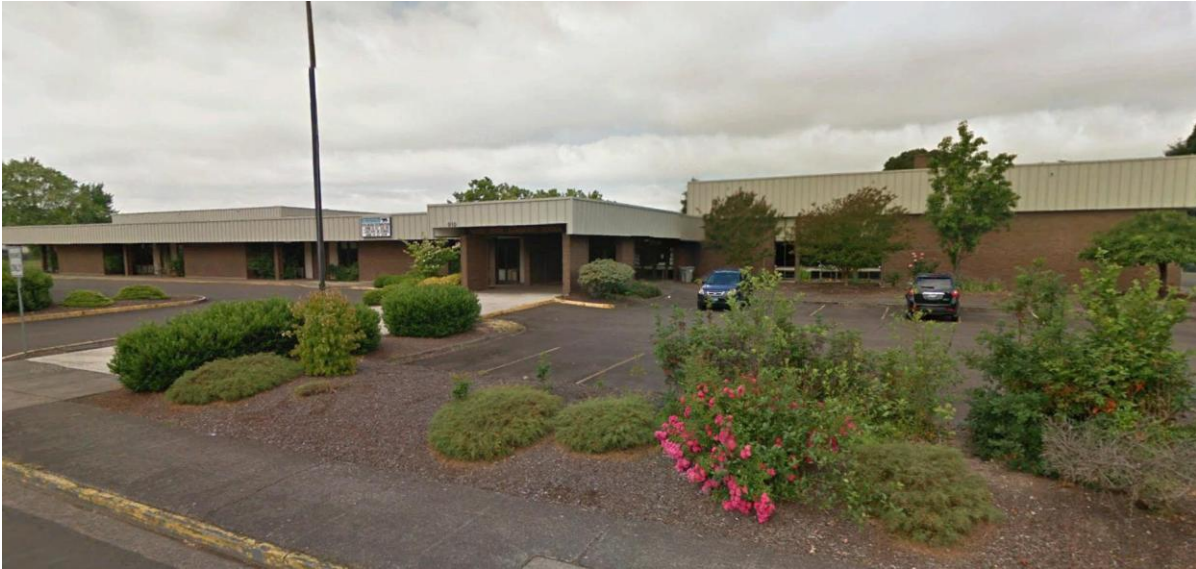
1. The existing parking lot for South Shore is configured such that there is no parent loop. Parents entering the parking lot must turn around and leave by the same entry point. If a loop was created for parents, the length would only accommodate 5 or 6 cars in line, which may not be enough to justify the cost. The existing bus loop could be modified depending on the number of buses serving the site to shift it enough to fit a couple more cars, but not more than that. This may not be a significant enough of an improvement to justify the costs for this change. This change has not been included in the report.

Main entry to South Shore Elementary School

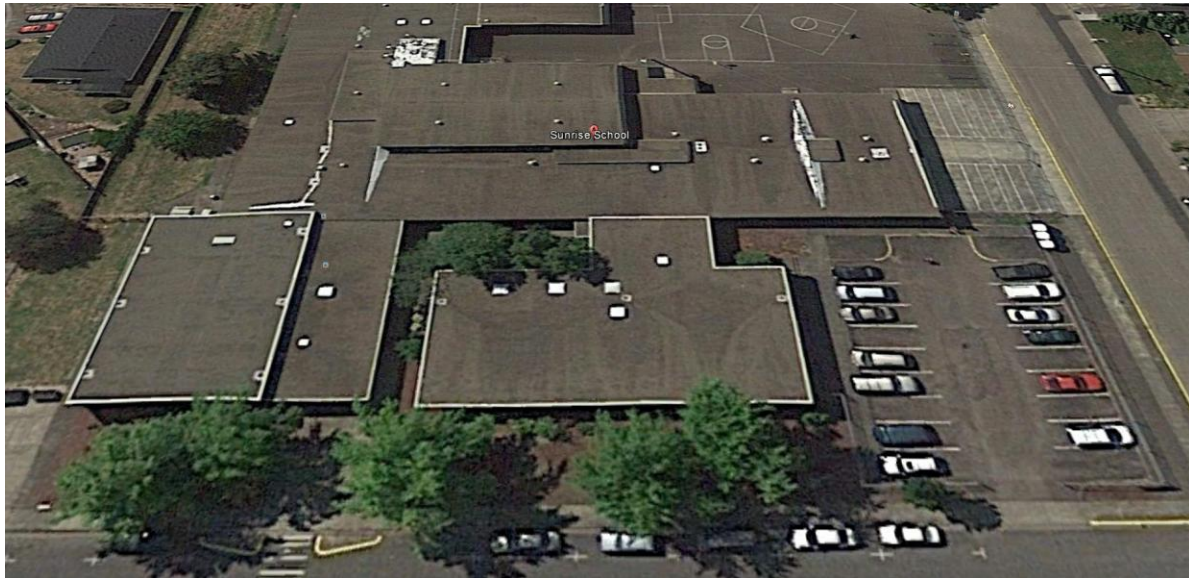
3. The site which the building is located on is long and narrow which makes accommodating a bus loop and a parent loop difficult. About half of the parking for the site is located across the street from the school. The school is bordered by a dead end street to the West which is used as the bus loop for the facility. A large turn around area is provided which requires vehicles to back up into the street. An improvement could be considered to create a turnaround loop toward the end of the street, however grass play area which is already limited, would be significantly impacted. Neither a bus loop nor a parent loop has been proposed in this report.

Entry at Sunrise Elementary School through deep courtyard

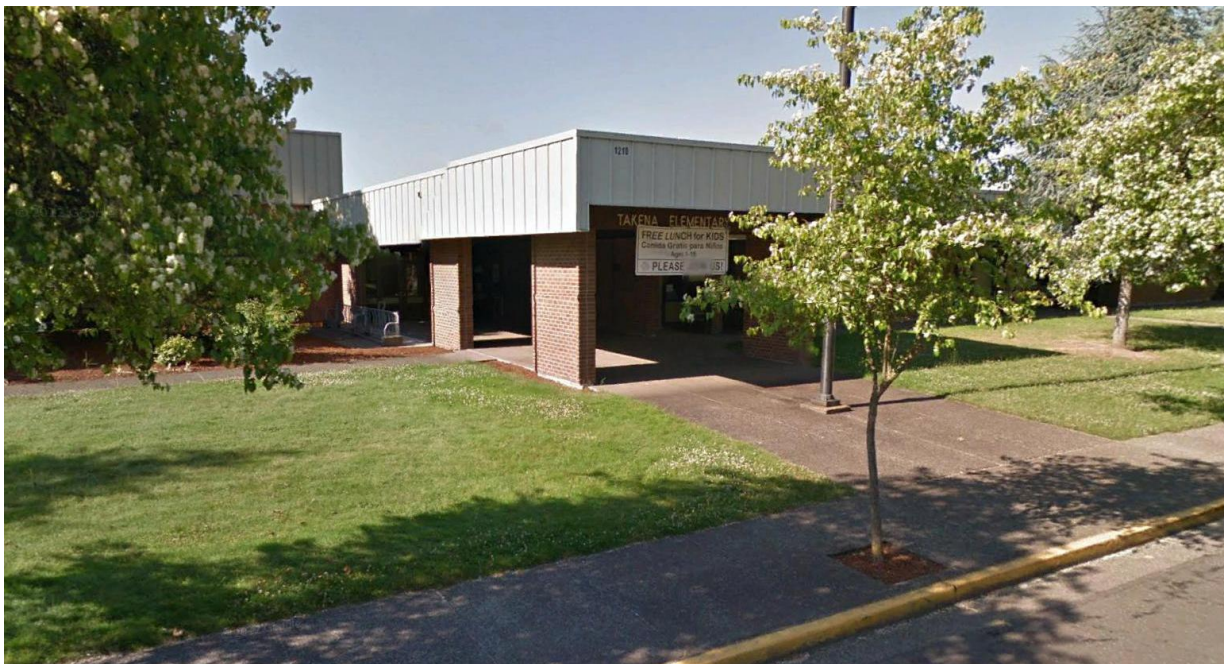
1. Takena has the same floor plan as South Shore and Oak Elementary Schools except that the classrooms along the East side of the building were omitted. This has created a disparity in that Takena's square footage per student is more than 50% larger than the school district average. The number of classrooms is low when compared to the square footage of support space.
2. Takena has the same lack of parent loop issues as South Shore and Oak Elementary Schools, however the building is located much closer to the street, which reduces the opportunities. The existing parking lot to the North is oriented such that creating a loop through doesn't work properly. It would be possible to create a turnaround loop through to the Eastern parking area for buses, however its orientation would be backwards for parents, so a parent loop has not been included.

Main entry to Takena Elementary School in close vicinity to street

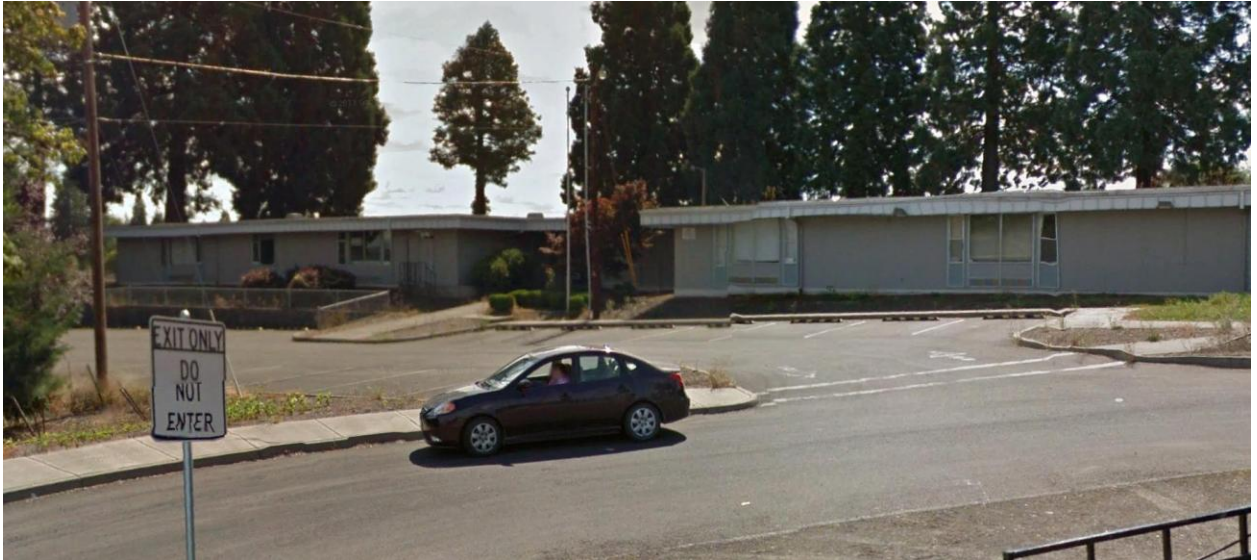
The building, which appears to have been vacant for a while, is deteriorating. Water leaks have compromised the floor tile in one section of the hallway, and in one of the rooms. Sections of the ceiling have been opened up to allow the leaking area to dry out, and other areas are stained.

Main entry to Fir Grove Elementary School centered in photo up steep walk.
